AGS DIVISION TECHNICAL NOTE

No. 9

November 30, 1965

STATUS REPORT (3) CONCERNING HIGH GRADIENT COLUMN AND
50 MEV FAST EMITTANCE DEVICE

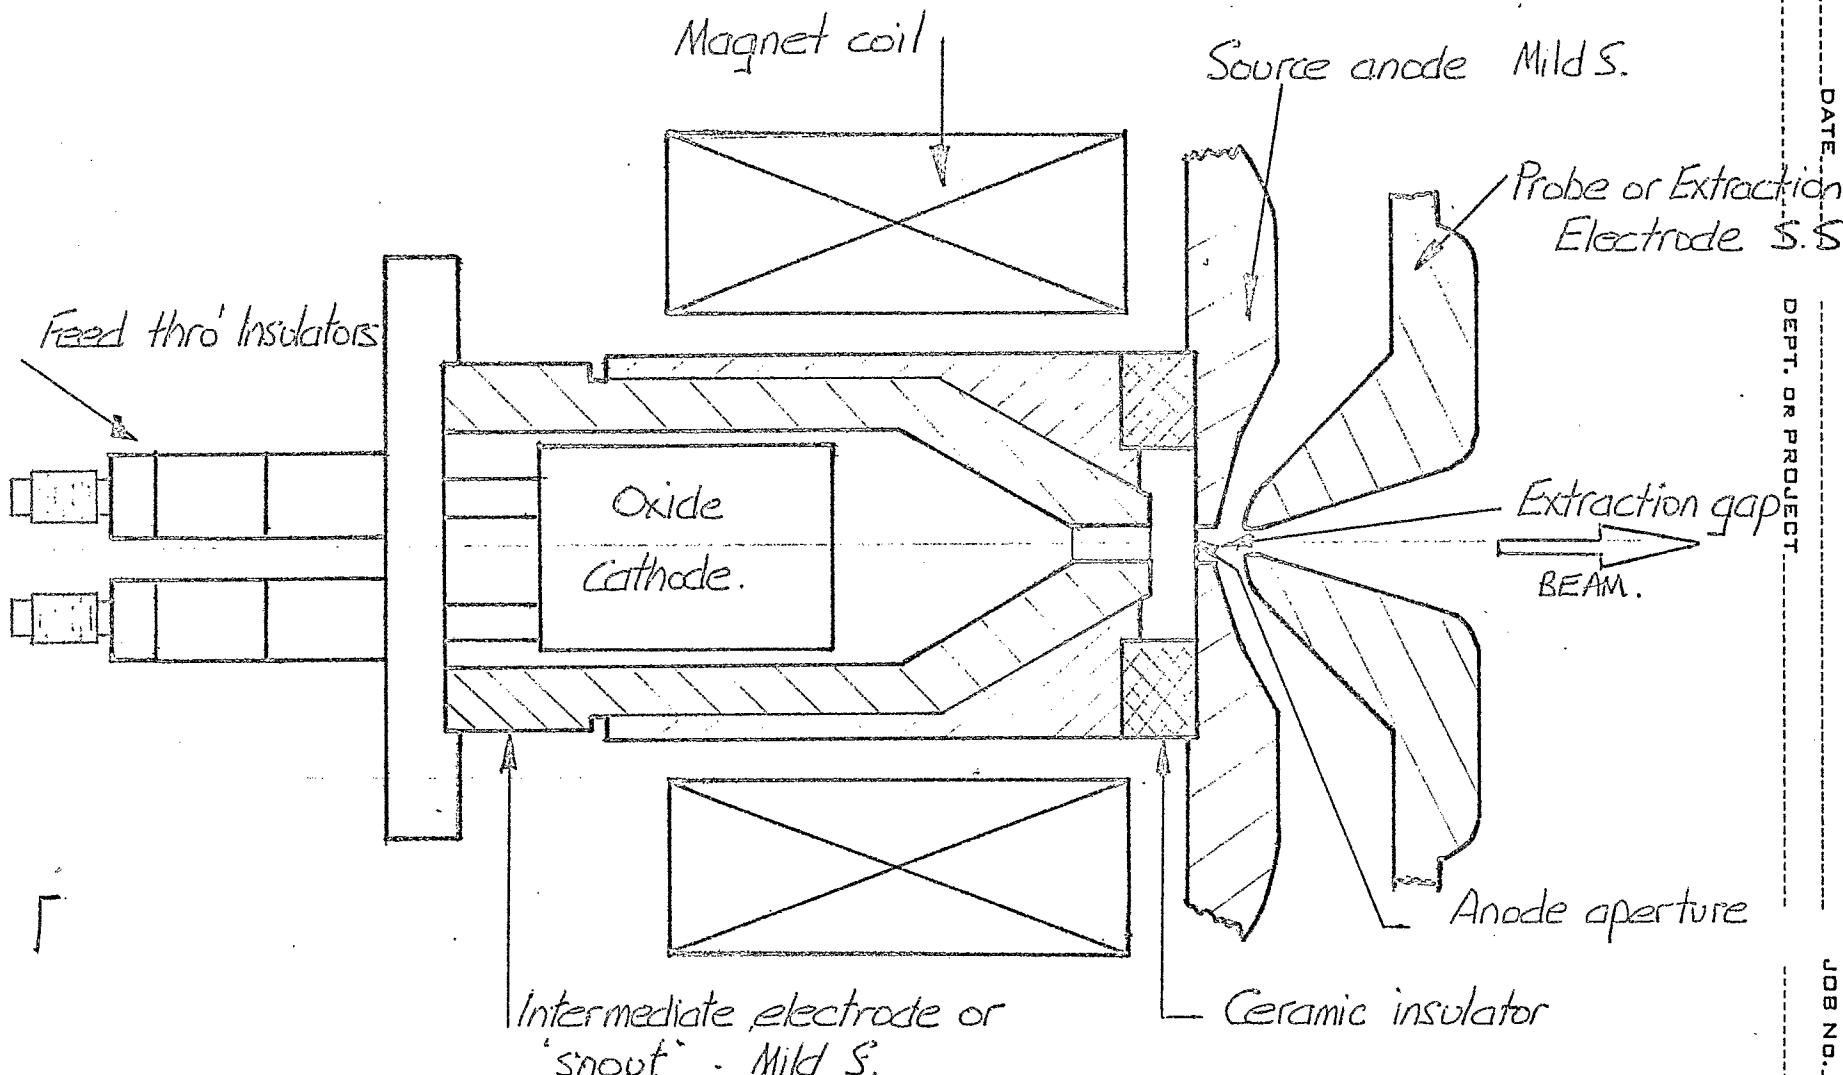
Fig. 1

MAIN COMPONENTS OF OPERATIONAL DUOPLASMATRON. ION SOURCE

During the shutdown, a duoplasmatron with small expansion cup ($\emptyset = 4$ mm) has been installed in the present preinjector. After some minor technical difficulties, (e.g., cooling problems of magnet and housing of the palladium leak; we now use freon supplied from a cooling unit on the bottom of the pit via teflon tubes) this source supplies around 75 mA after the column and injected without loss into the linac. Focusing at the low energy end of the column is performed like the one used with the PIG source; the geometry of the extractor has been modified into a "Berkeley" shaped one (see Fig. 1). Though the source output current can be as high as 200 mA, (see Status Report 2) upper limit of the present column plus pre-focusing system seems to be around 100 mA. At the high energy end the gridded electrostatic lens has been removed to increase the beam brilliance. The emittance (area/ π) measured at 750 keV is 8.7 cm mrad (brilliance around 1.5×10^8). A mean value of the PIG source (measured over June-July) is $.7 \times 10^{8*}$. With 30% H_2^+ an acceleration efficiency was obtained of 60%.
